Austin MG

SUBJECT: COOLING FAN THERMAL CUT-OUT INSTALLATION

MODELS: 1977 MGB

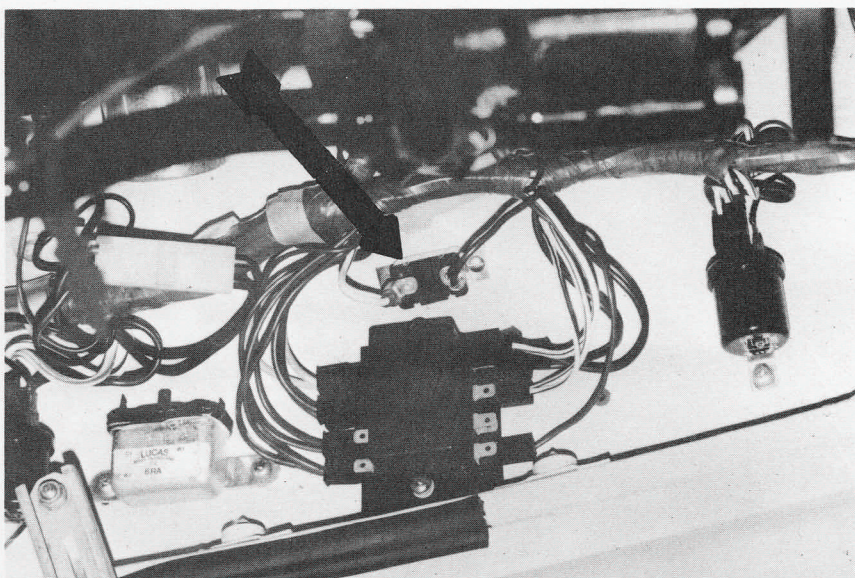
The in-line fuse is located on the right inner valance of the car, underneath the fuse block, has a green lead on one side and a white with brown tracer on the other. The diagram below indicates the correct location of the thermal cut-out.

20 Amp Thermal Cut-Out Switch

As a courtesy service to all owners of 1977 MGBs we would ask that during pre-delivery or at the next convenient service, the in-line fuse which controls the cooling fans be removed and replaced with a thermal cut-out which is available under part #BLM 601018.

This thermal cut-out has a maximum rating of 20 amps and is self-healing, in the unlikely event that an overload condition should occur.
